Restoration Success

By Lori Froehlich

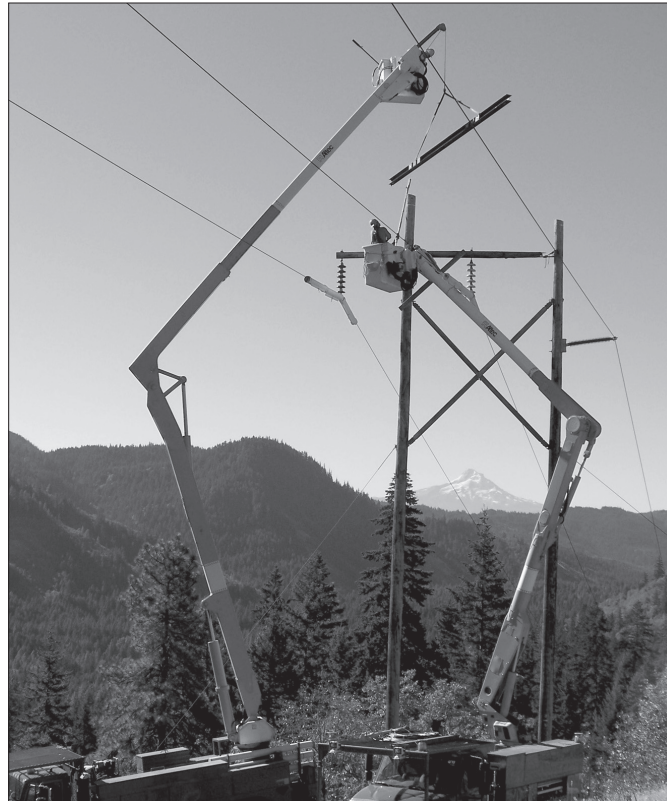
Repairs are made to the damaged structure on the Glenwood transmission line, while the line remains energized, or hot. Lake Howard flies the cross-arm in to Jeff Speelman and Todd Niva in the bucket.

chilly conditions, they located a broken cross-arm on September 25 around 1 a.m.

The cross-arm was located on a structure that was part of a canyon crossing in an extremely steep, difficult-to-access location, with no road and many obstacles. Luckily, Klickitat PUD linemen are problem solvers and they quickly came up with a plan to access and attack the problem. They made short-term repairs to the cross-arm and put the wire back in the air. At almost 5 a.m., the work was completed and the power was flowing back to the 300 homes and businesses in the Glenwood valley.

Final repairs were completed the next week during normal business hours, and a new metal cross-arm replaced the wooden one. These repairs were made without an outage to Glenwood customers.
